AVON WATERWAYS COMMITTEE
RIVER RECOVERY PLAN
Section 14,15,16 – Beverley to Qualandary Crossing

prepared by
Roger Underwood of York Gum Services
for
Water and Rivers Commission
and
Avon Waterways Committee

WATER AND RIVERS COMMISSION
RIVER RECOVERY PLAN
REPORT No RRP 5
JANUARY 2002

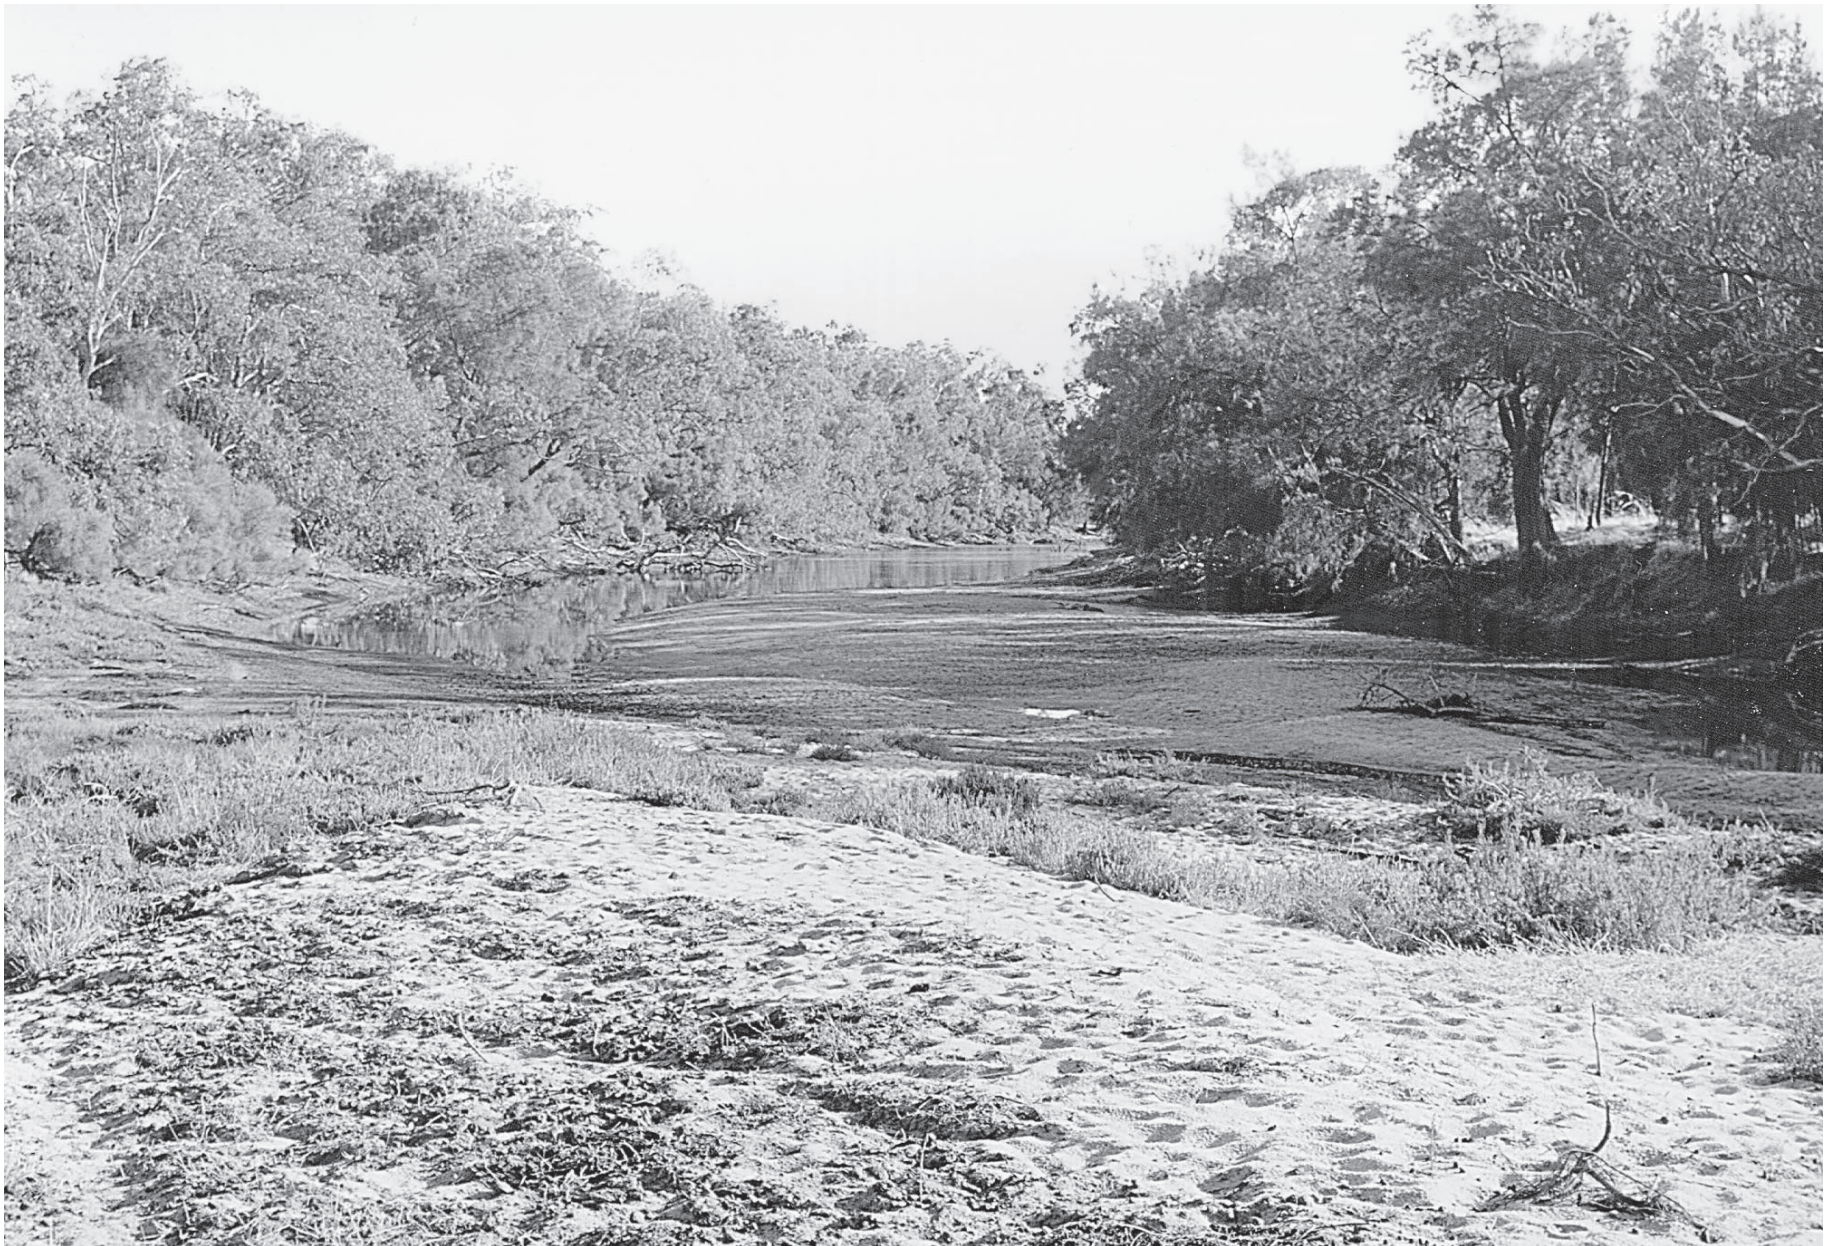
Sediment slug approaching Eyres Pool

A major cause of down-river sediment movement is the higher velocity of the river in the wake of the River Training Scheme.

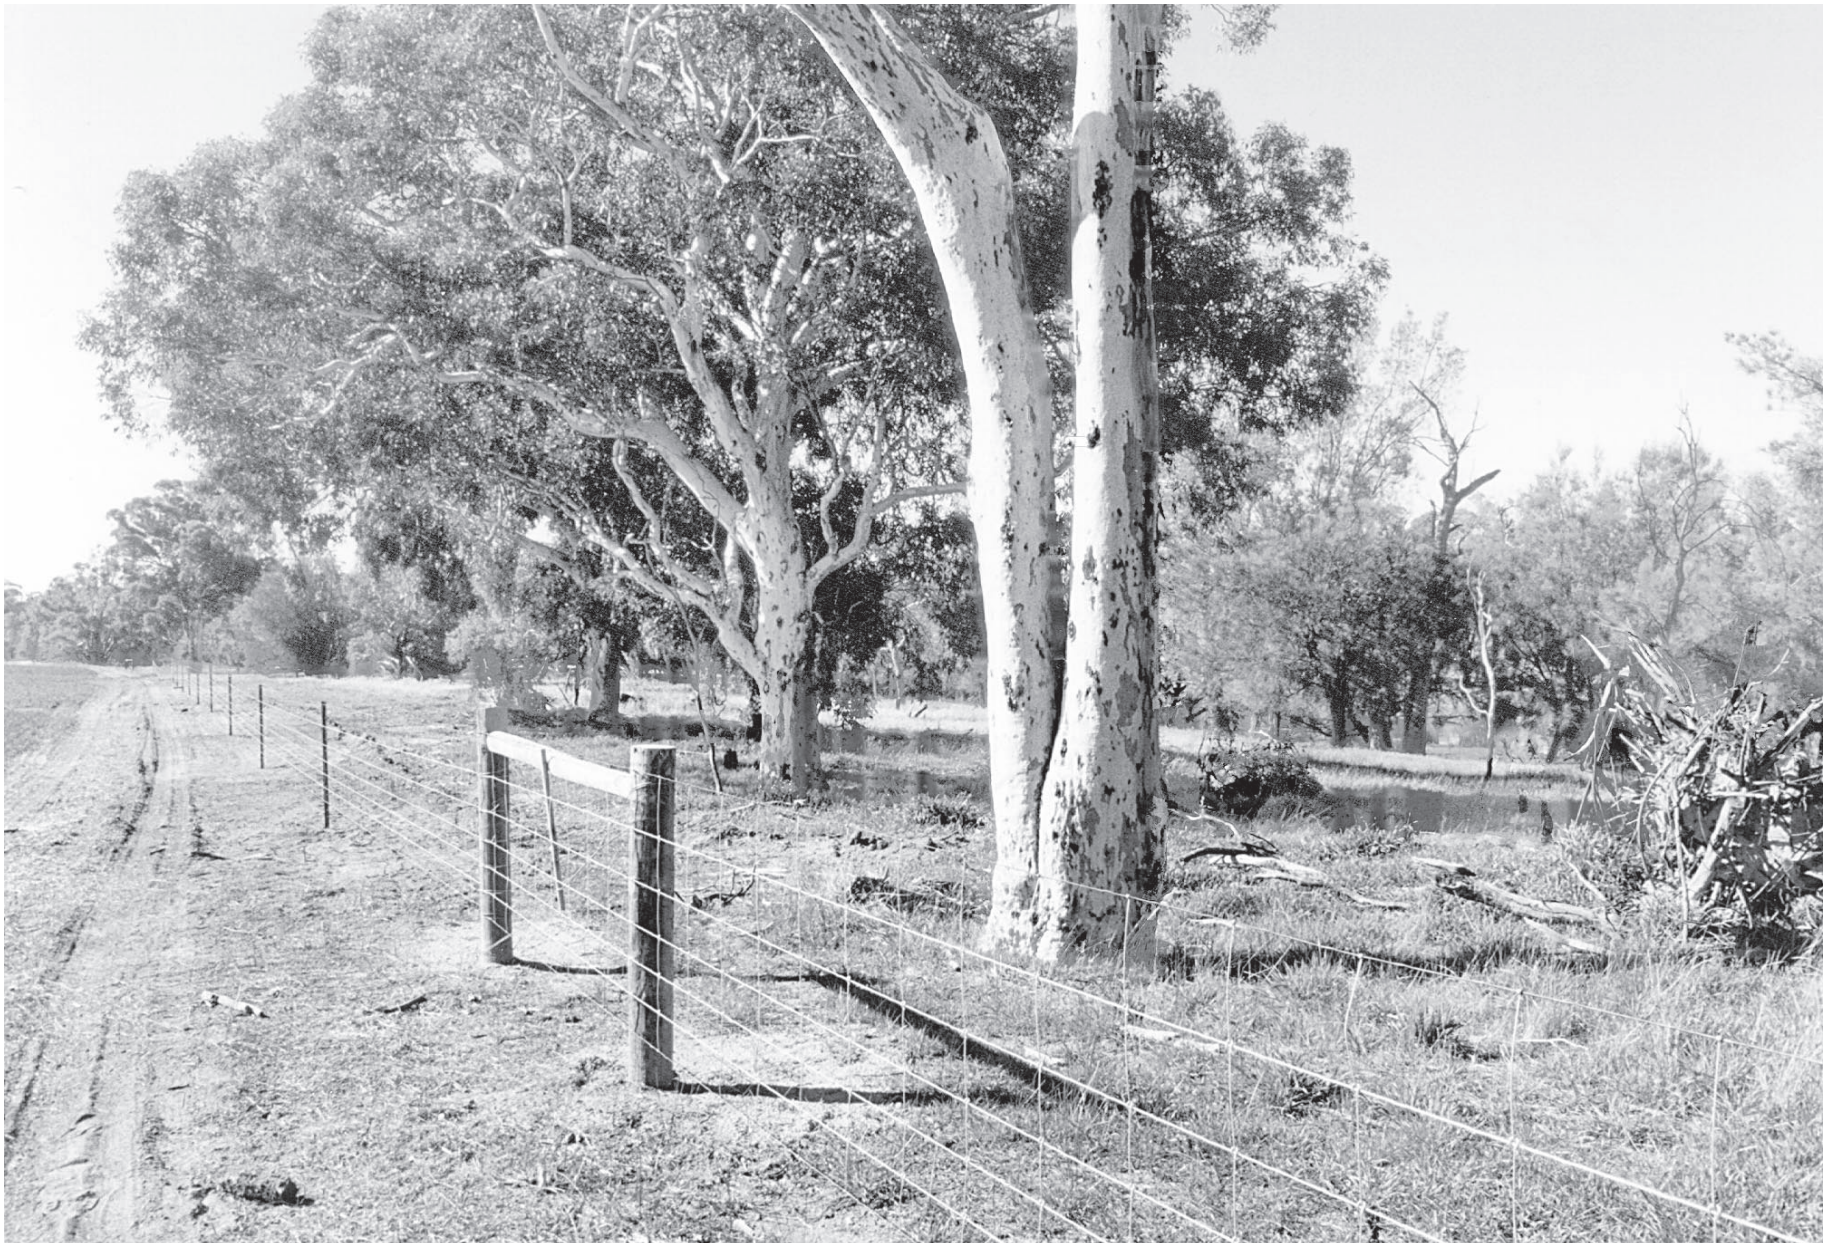
Fencing along the Avon River

- Fenced both sides = 29.5 km
- Fenced one side = 9.5 km
- Fenced neither side = 2 km
- 24.5 km of existing fencing require maintenance/replacement in order to be stock (sheep) proof.
